SUBJECT: Youngs Dam, Dam ID No. 569, Kalkaska County

**DAM SAFETY INSPECTION REPORT
YOUNGS DAM – DAM ID NO. 569
SOUTH BRANCH BOARDMAN RIVER
KALKASKA COUNTY – SECTION 21, T 26N, R 08W**

October 12, 2021

December 20, 2021

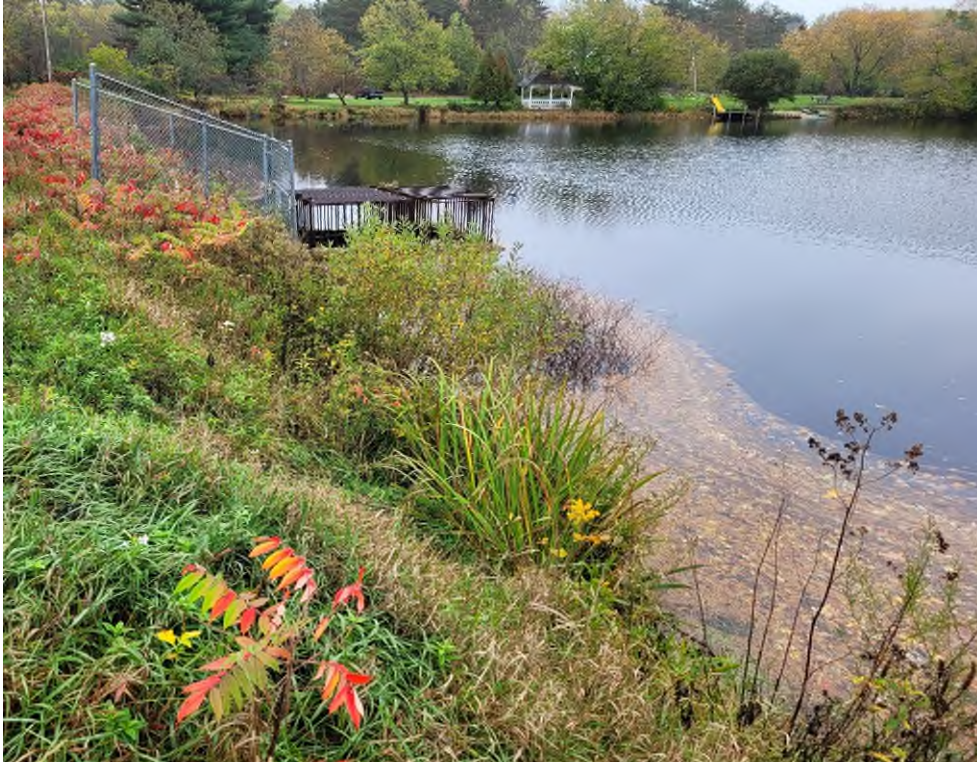
Upstream Slope	
Pool elevation at time of inspection (ft)	<i>At the top of concrete on primary spillway</i>
Upstream slope ground cover	<i>Riprap, grass/vegetation</i>
What issues are present on the upstream slope?	<i>Overgrown vegetation</i>
Slope Protection	
What types of slope protection are used?	<i>Riprap, vegetation</i>
Average diameter of rockfill	<i>3"-8"</i>
Condition of riprap	<i>Vegetation present</i>
Action required for riprap	<i>Maintenance</i>

Photo #1 – Upstream slope looking right from left abutment

- Trees and woody vegetation should be removed 10 feet past the toe of the embankment by December 31, 2022. Vegetation within riprap should be removed by trimming or chemical application.

Describe action required	<i>Remove vegetation from riprap by trimming or chemical application.</i>
Trees/Woody Vegetation	
Brush coverage	<i>Uniform</i>
Location of brush	<i>Upstream slope</i>
Action required for brush	<i>Maintenance</i>
Describe action required	<i>Remove brush from entire embankment to 10' beyond toe of slope.</i>

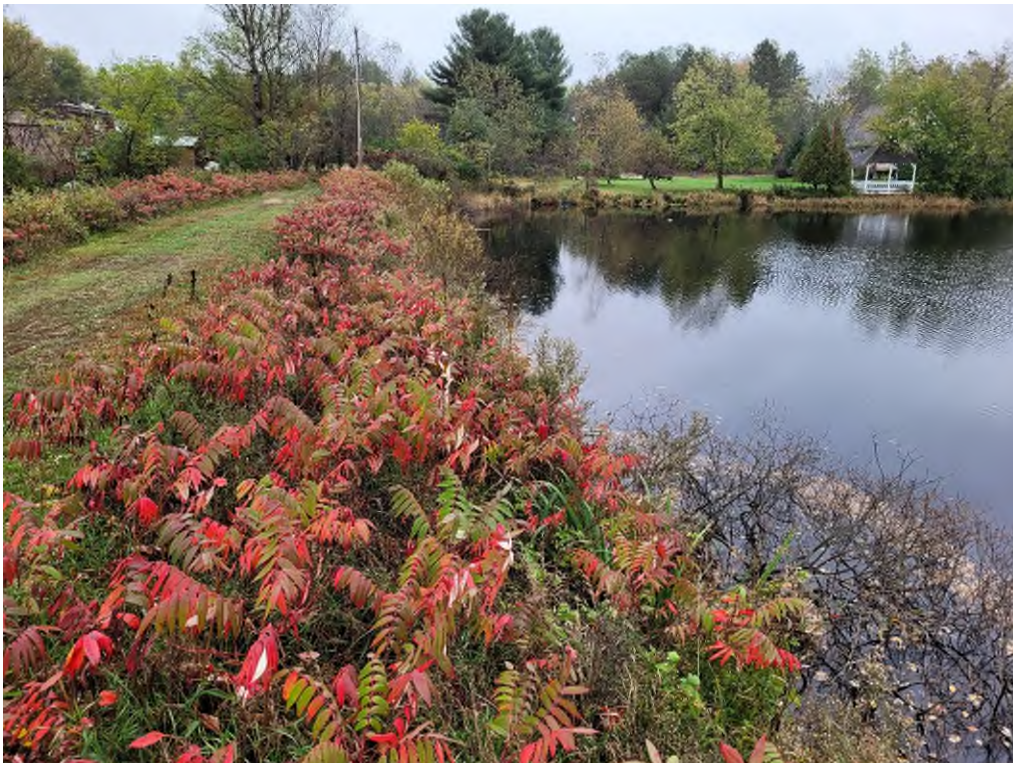
Photo #2 – Upstream slope looking right

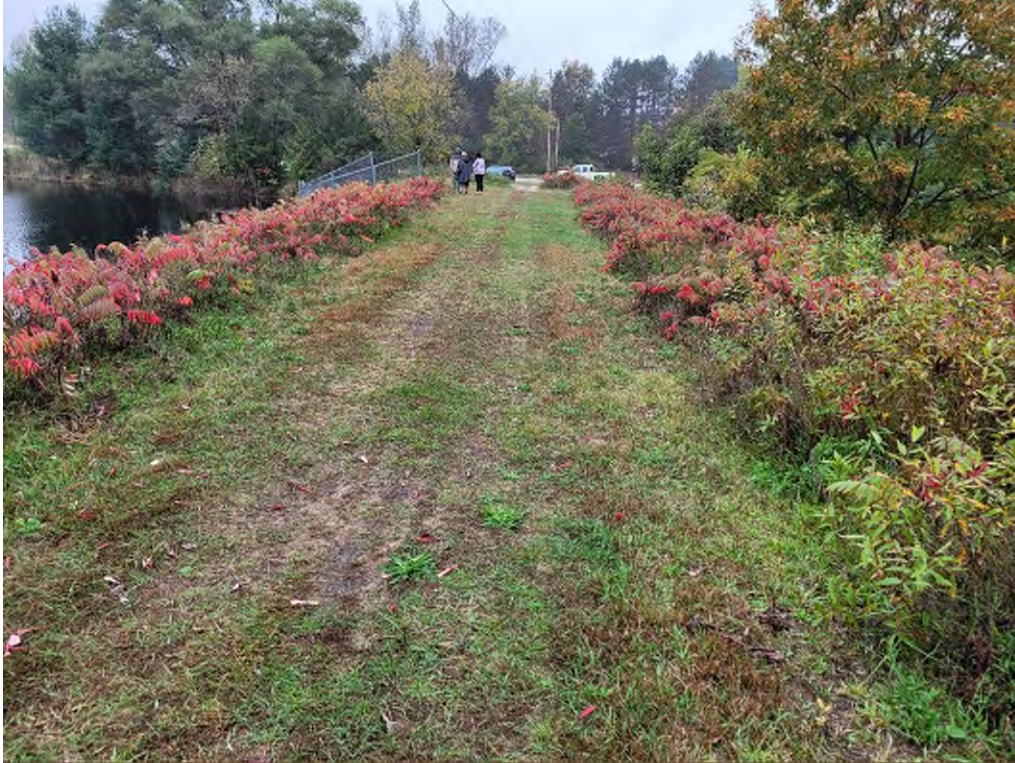
Photo #3 – Dam crest looking left

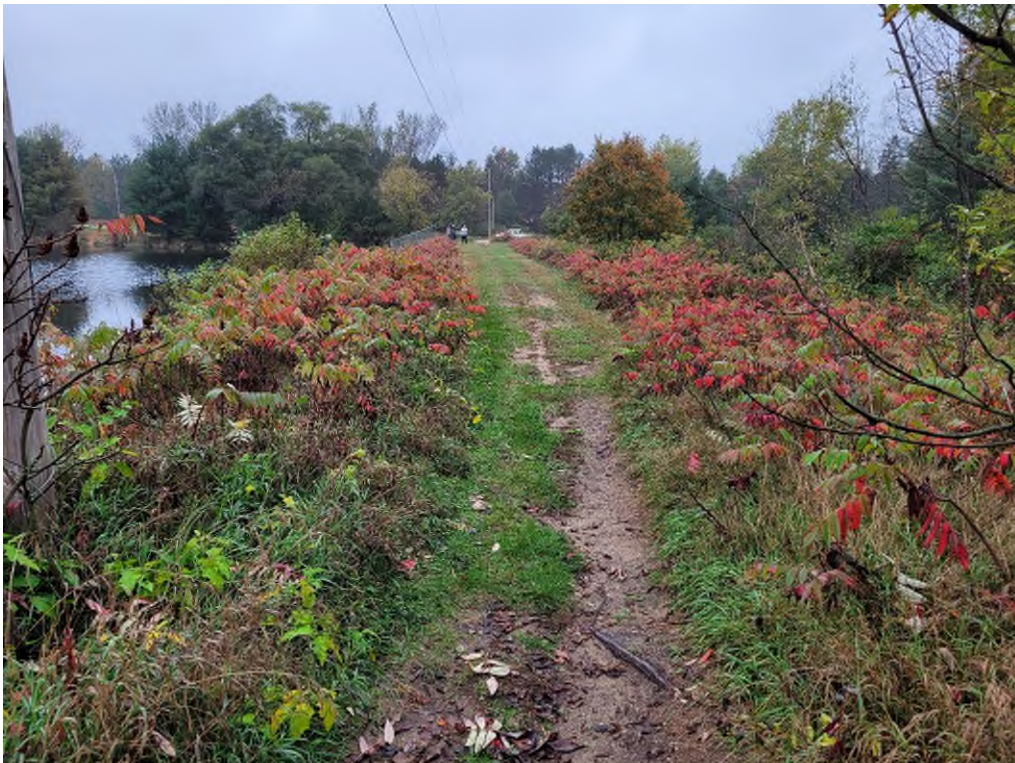
Crest	
Approximate width of crest (ft)	<i>12</i>
Approximate freeboard (ft)	<i>3.5</i>
Crest ground cover	<i>Grass covered walking path</i>
What issues are present on the crest?	<i>Low area</i>
Vertical Alignment / Low Areas	
What type of low area is present?	<i>Constructed dam crest</i>
Where is the low area located	<i>At the right and left abutments, both upstream and downstream groins.</i>
Approximate area (ft ²)	<i>Entire abutment area out to Butler Road at the right abutment and entire abutment area at left abutment.</i>
Action required for low area	<i>Monitor</i>
Describe action required for low area	<i>Monitor water levels in impoundment. If water begins to approach dam crest in the low area, placement of sandbags may be necessary to keep water from flowing over undesired areas.</i>

The inspection confirmed previous reports that the right and left abutments of the dam are approximately 2 to 3 feet lower than the elevation of the crest of the embankment. This means that at high flood events, water will begin to spill over both abutments before ever overtopping the embankment. The abutment areas are well vegetated, relatively flat, and more than 100 feet wide. These areas will provide more than adequate capacity for flows greater than the design flood event.

Photo #4 – Dam crest looking left from right abutment (low area)

- Monitor water levels in impoundment for potential overflow at each abutment. These areas should be raised to contain the flood stage during the 100-year event or armored for anticipated overtopping during lesser events. Provide a plan to the Dam Safety Program by December 31, 2022 detailing the anticipated direction to remedy the deficiency.

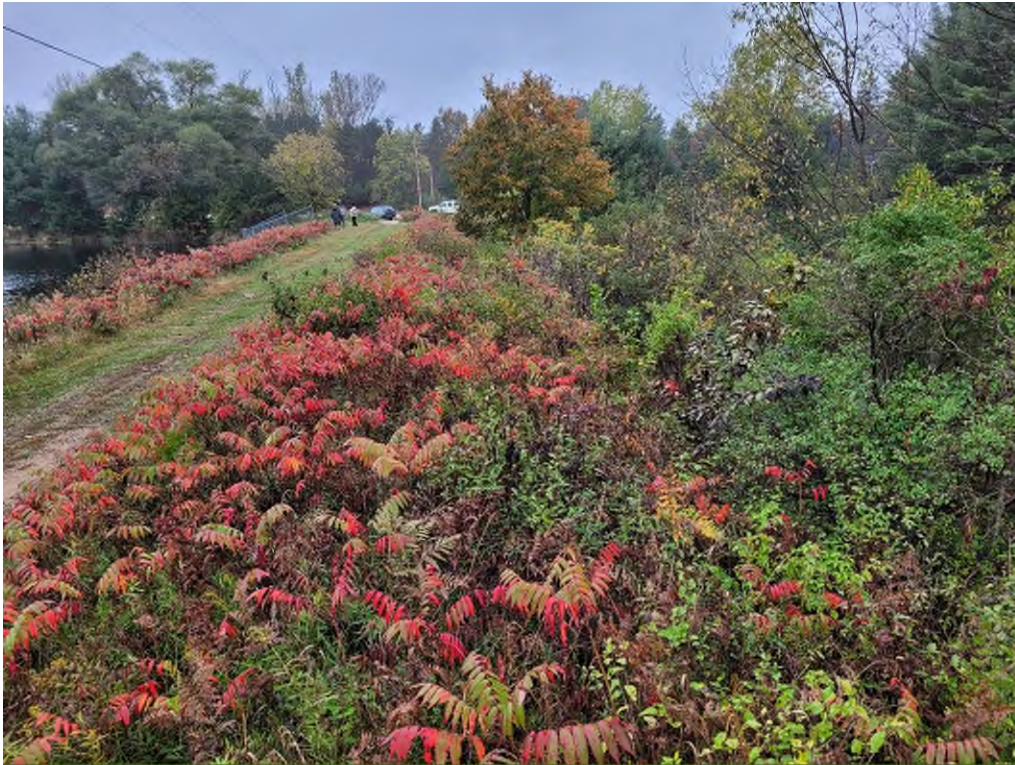
Downstream Slope	
Downstream slope ground cover	<i>Grass</i>
What issues are present on the downstream slope?	<i>Trees, brush</i>
Trees/Woody Vegetation	
Number of trees	<i>Dense</i>
Tree DBH	<i>3"-12"</i>
Tree location	<i>Entire downstream slope of embankment</i>
Action required for trees	<i>Maintenance</i>
Describe action required	<i>Remove trees on embankment 10' past the toe</i>
Location of brush	<i>Entire downstream slope of embankment</i>
Action required for brush	<i>Maintenance</i>
Describe action required	<i>Remove brush from entire embankment to 10' beyond toe of slope.</i>
Ground Cover / Vegetation Issues	
Ground cover type	<i>Grass with foot path, trees/brush</i>
Ground cover issues	<i>Bare</i>
Location of ground cover issues	<i>Footpath from dam crest down to outlet pipe</i>
Action required for ground cover	<i>Maintenance</i>
Describe action required	<i>Implement erosion control measures as needed</i>

Photo #5 – Downstream slope looking left from right abutment

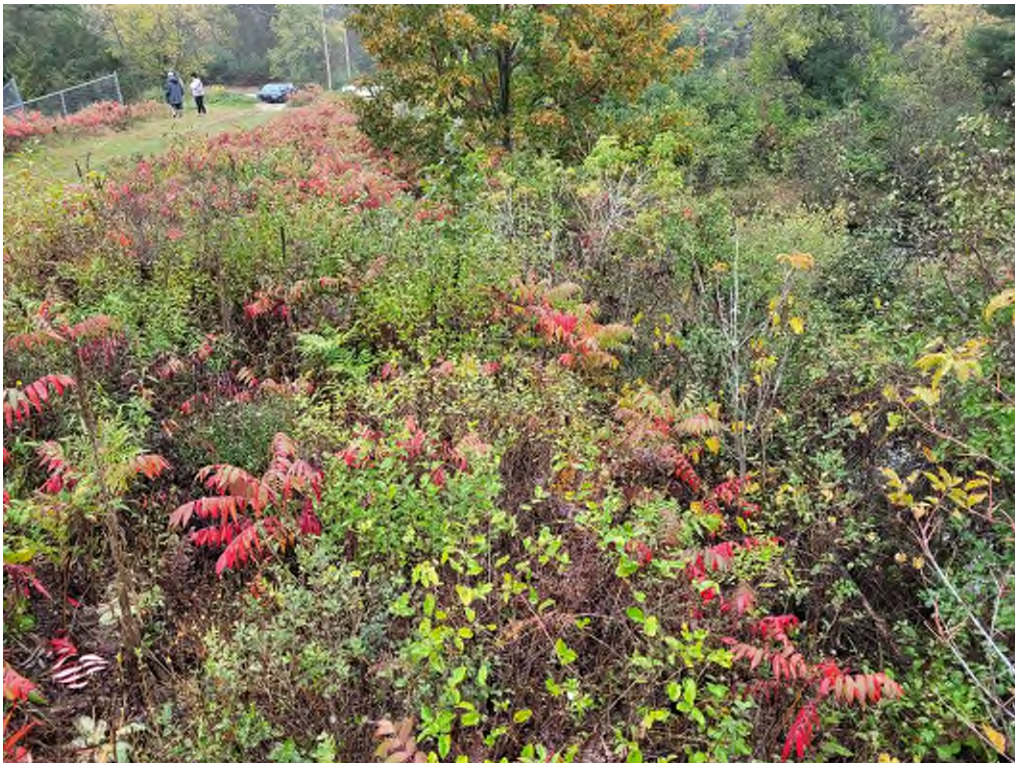
Photo #6 – Downstream slope looking left

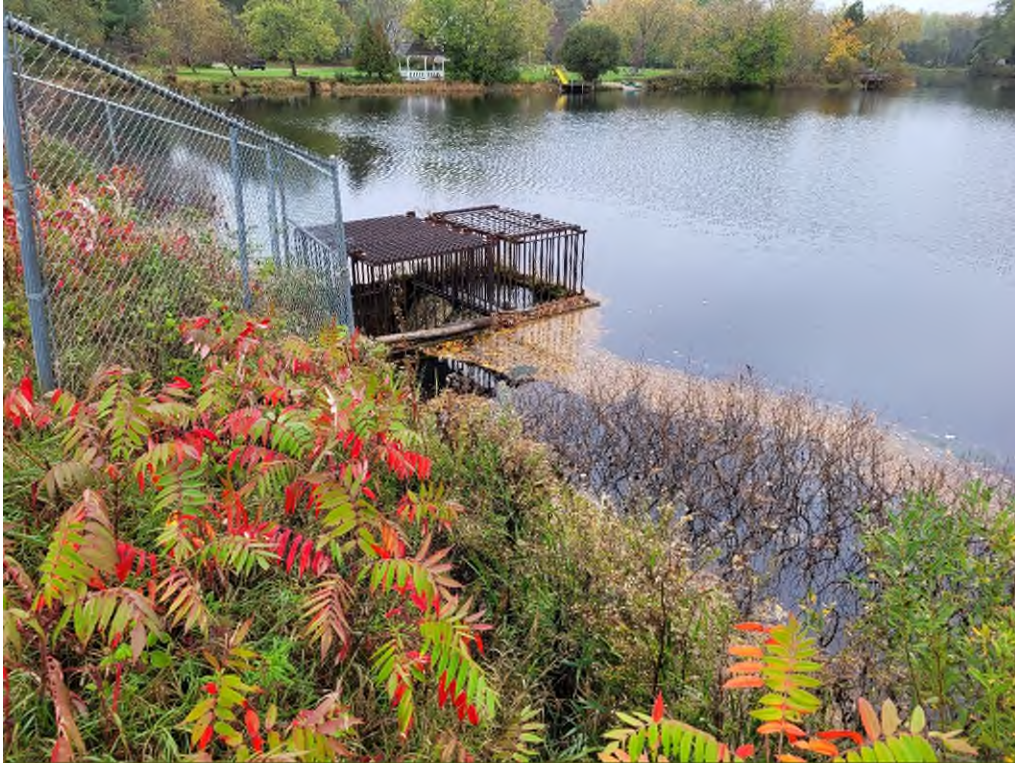
Principal Spillway	
What type of spillway is present?	<i>Weir/Channel</i>
What type of weir is present?	<i>Sharp crested drop inlet</i>
What is the primary material used in the spillway?	<i>Concrete</i>
What issues are present with the primary spillway?	<i>Vegetation, obstructions, deteriorating material</i>
User Defined Issue	
Specify other.	<i>Vegetation growing</i>
Where are the other issues located?	<i>Within concrete structure</i>
Action required for other issues	<i>Maintenance</i>
Describe action required	<i>Remove vegetation</i>
Obstructions	
What is obstructing the spillway?	<i>Debris</i>
What type of debris?	<i>Leaves, logs</i>
Where is the debris?	<i>Inlet</i>
Action required for debris	<i>Maintenance</i>
Describe action required	<i>Remove debris as frequent as necessary to maintain spillway capacity.</i>
Material Deterioration	
What materials are deteriorating in the spillway?	<i>Concrete</i>
What issues are noted with the concrete components?	<i>Cracking</i>

How large is the impacted area (in ²)?	<i>Varies</i>
Where are the issues located?	<i>Top of principal spillway and inside walls of drop inlet</i>
Action required for concrete components of the spillway	<i>Monitor</i>
Describe action required	<i>Monitor cracking for further growth</i>
Spillway Conduit Issues	
Is there loss of joint material?	<i>No</i>
Where are the issues located?	<i>Outlet culvert</i>
Action required for joint separation	<i>Maintenance, Planning</i>
Describe action required	<i>Begin planning and budgeting for replacement of the steel outlet pipe.</i>
Erosion Control / Energy Dissipation	
What type of erosion control structure is in place?	<i>Rock-Lined Channel</i>
Does the outlet erosion control structure include any drains?	<i>No</i>
Gates / Valves	
Does the spillway include a gate?	<i>No</i>

Photo #7 – Primary spillway looking upstream

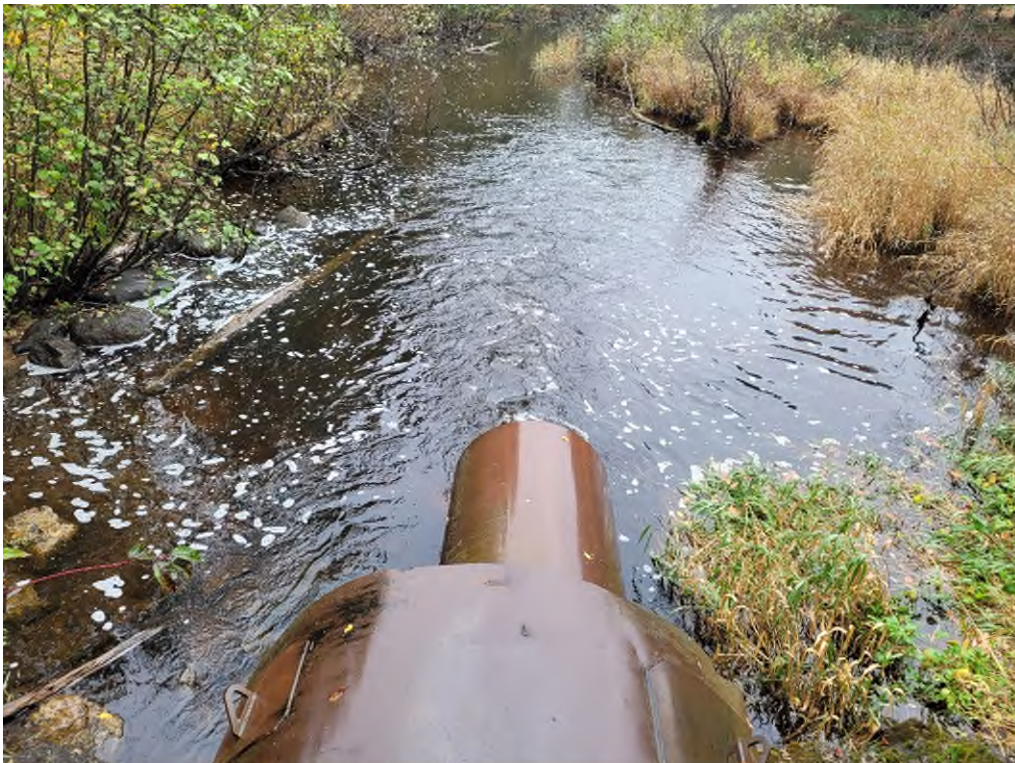
The owner has placed a pipe of smaller diameter inside of the outlet pipe in order to deflect water flow from the original pipe. This pipe is not effective, as flow is still making its way through both pipes. The original outlet pipe is over 50 years old and is well beyond its expected service life. Failure of outlet pipes is a common cause of dam failure. Planning should begin immediately for the financing and repair or replacement of the outlet pipe within five years.

Photo #8 – Primary spillway outlet looking downstream

- Immediately begin planning and budgeting for replacement or repair of the steel outlet pipe and should be completed within five years. This work will require a permit from this office.

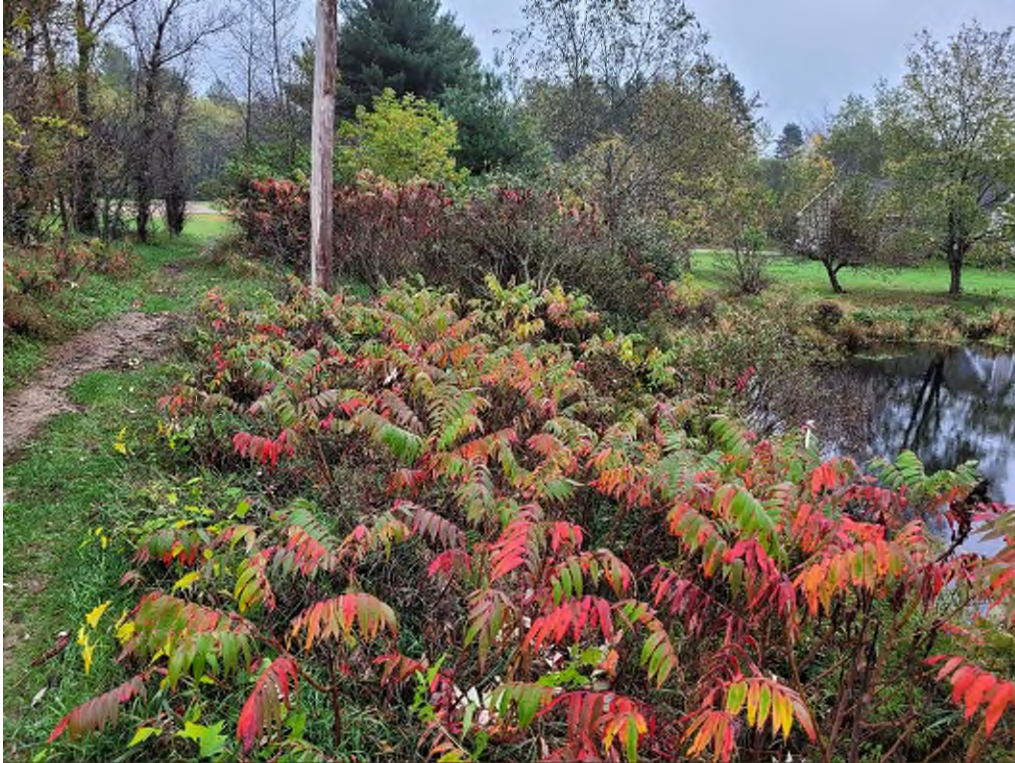
Photo #9 – Low area at right abutment, looking right

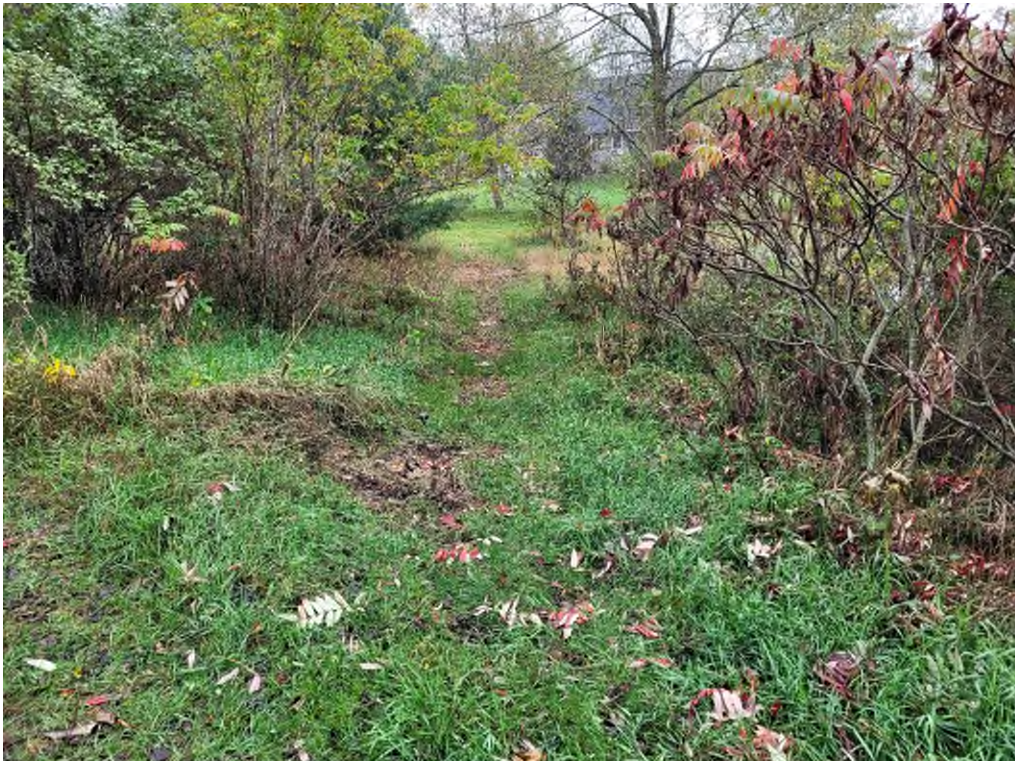
Photo #10 – Low area at right abutment, looking downstream
